Gallagh Group Water Scheme (GGWS)

**Submission to**  
**Multi-Annual Rural Water Programme 2024-2026**  
**Measure A4**

**Replacement of 7" Spine Main (Trunk Main)**

**Replacement of revenue meters, control valves and other assets**

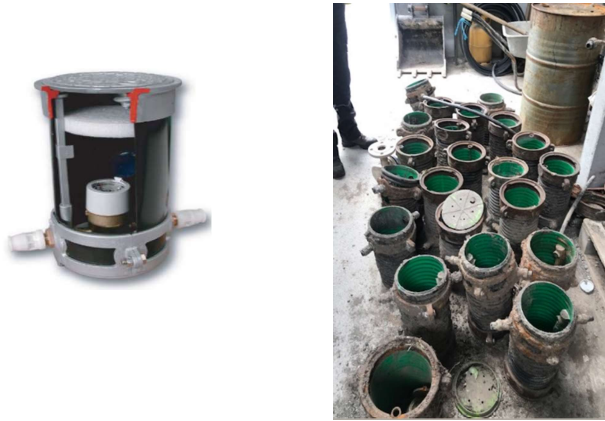
Figure 2: A WSC-R customer access box and some of the old WSC-R boxes after being replaced

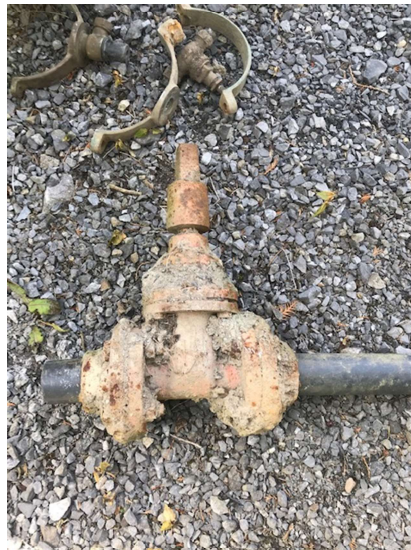
Figure 3: Typical Original Sluice Valve

When the scheme was originally constructed, all spurs off the spine mains were controlled by sluice valves at the change of diameter or tees on the mains. These valves are now continuously failing as they are heavily corroded and if the operative manages to open or close them, they result in leakage on the valve glands.

Figure 3 shows a typical valve replaced on the scheme in 2020.

This can be achieved by replacing the failing 20-year-old meters with new meters and by replacing all original control valves.

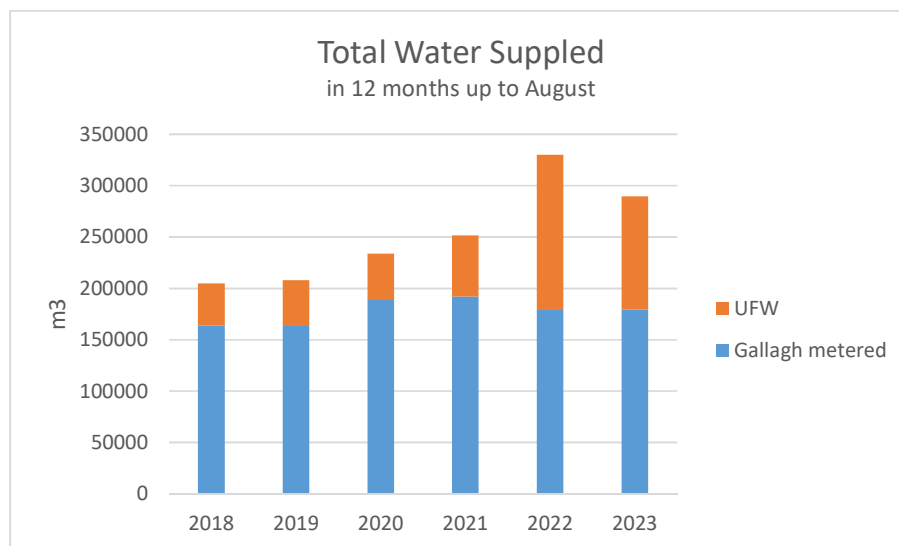
Figure 4

GGWS had an acceptable level of UFW (<25%) up to August 2021, but by August 2022 the UFW had doubled. This was the period when the 7" spine main began to fail. GGWS introduced an active leakage find and fix programme in early 2022, and had already fixed several leaks by August. However, new leaks continued to appear and the UFW was still high a year later, despite best efforts to react quickly.

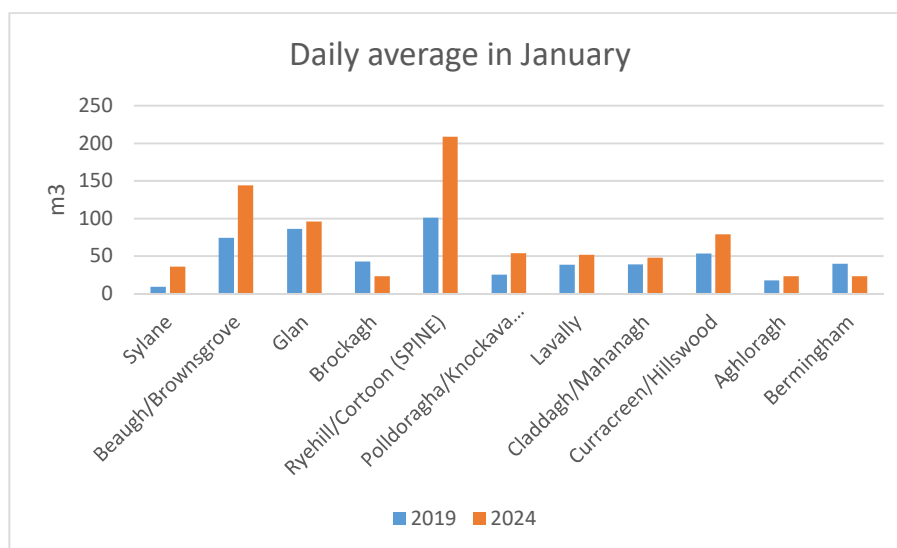
Daily usage in the eleven DMAs of GGWS was averaged over the month of January 2019 and also in January 2024. The comparison in Figure 6 shows that usage increased in most DMAs. Note that an extensive find and fix programme solved an over-consumption problem in Brockagh. The Beagh/Browns Grove DMA needs some attention, but the biggest problem lies in the Ryehill/Cortoon DMA, which is the 7" spine main. It shows more than 100% increase in consumption in January 2024 compared to five years ago, despite all the leak fixes in 2022 and 2023.

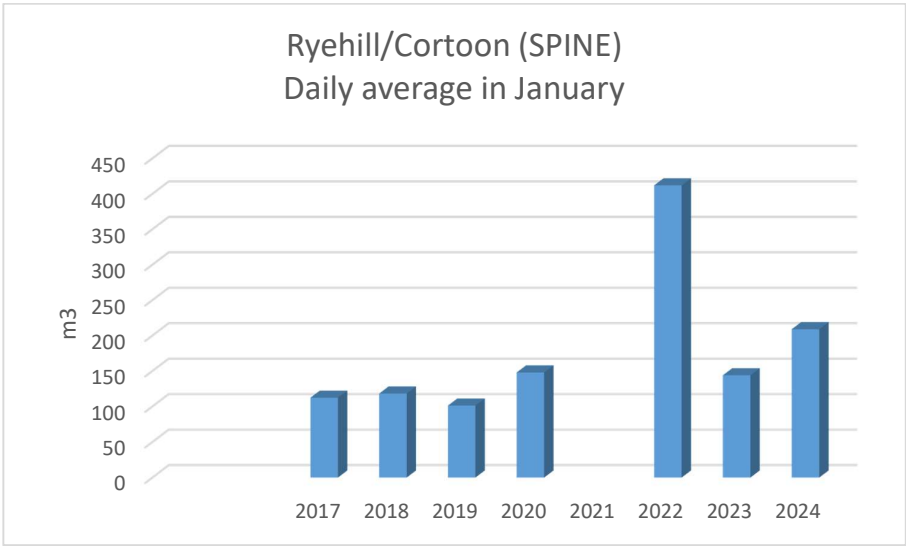
A closer look at the data for the spine main DMA in Figure 7 shows a marked increase in leakage in 2022. GGWS implemented a find and fix and valve replacement programme which was successful in reducing the daily demand to normal levels by June of that year, but it has increased again in 2024. This further indicates the urgency in replacing this critical asset to maintain the resilience of the network.

Note: The data for January 2021 is missing because one of the relevant loggers was out of action during that month.

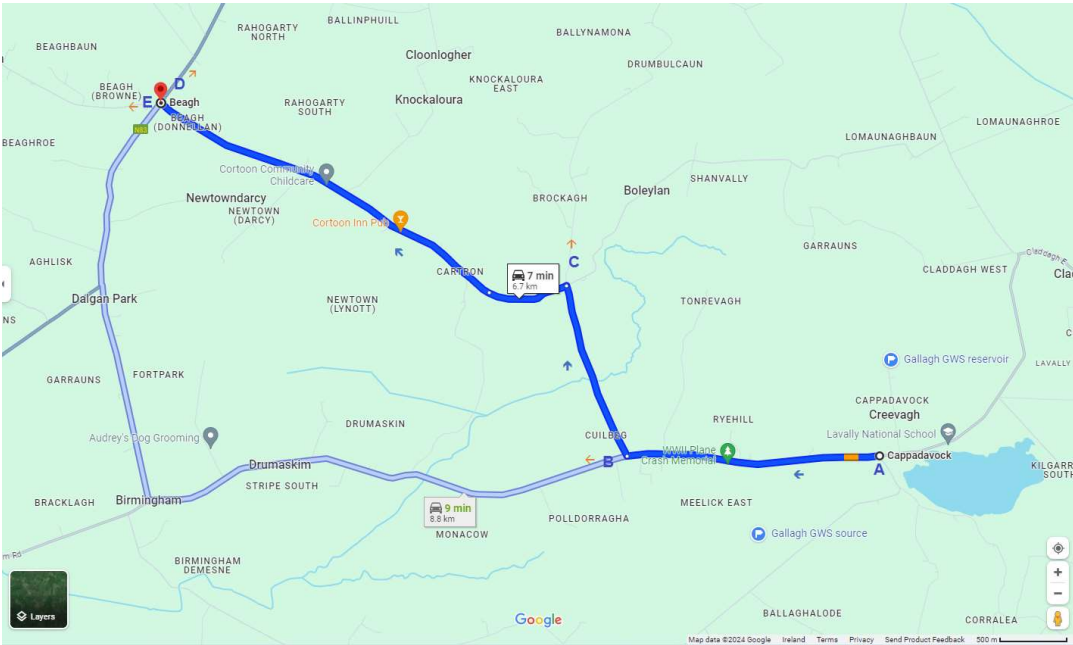
Figure 8

The 7” Trunk Main is monitored for leakage using the McHugh’s Bulk Meter (BM) as labelled and installed by Cully Automation Ltd in 2019. McHugh’s BM is located on the commencement of the 7” Trunk Main, Point A on the network map. In order to measure and monitor the consumption on the spine we need to subtract the other BMs located on spur mains at points B, C, D and E.

A – B – C – D – E = 8.89 m<sup>3</sup>/hr along 6.7 km of 7" pipe.

**Estimated night flow on spine main = 8.89 m<sup>3</sup>/hr ÷ 6.7 km = 1.33 m<sup>3</sup>/hr/km**

This is well in excess of the >0.4 m<sup>3</sup>/km/hr requirement in the framework document, Table 5  
– Water conservation priority rating – Priority B.

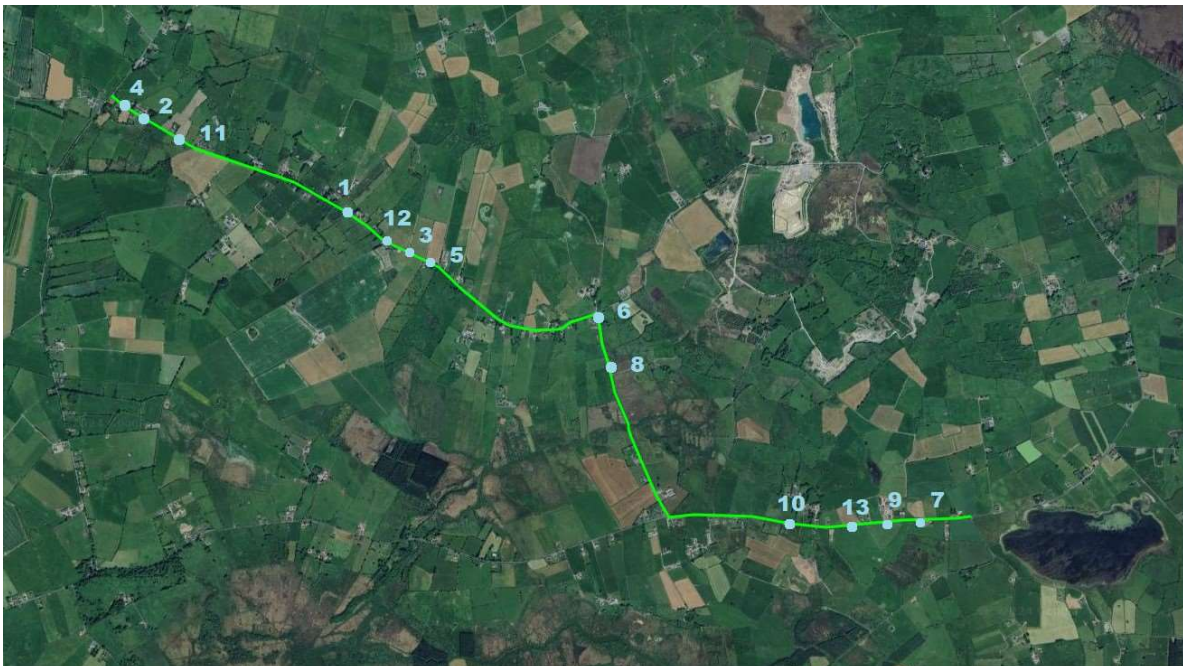
Figure 9

The 7" Trunk Main has failed on 13 No occasions over the past two years. The map below illustrates the location of these leaks along the 7 km of PVC main, numbered in chronological order. The dates of the leaks are shown in Table 3. Nine of these were splits in the pipe, of which two were repaired with a wrap and seven required a cut-out and replacement of a length of pipe.

**Appendix 2** contains charts of the bulk meter flow at the start of the spine main during periods when leaks were fixed. Significant volumes of water were lost. Sometimes the leak was not visible and took a while to find (leak 10, for example). Other times the leak suddenly flooded

the road, making it dangerous. On two occasions in 2023 (leak 8 and leak 9), the leak flow was so high that it exceeded the fill rate at the reservoir and required that the water be shut off overnight while mobilising a crew to dig the following day.

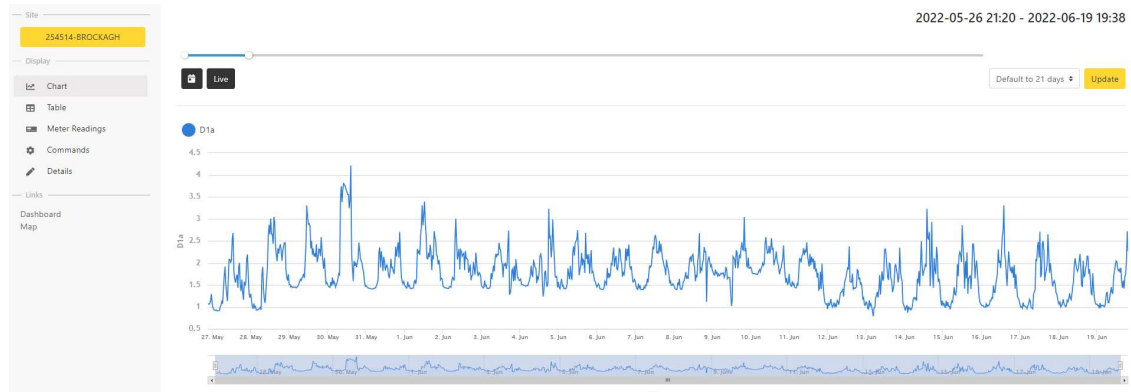
1. Brockagh bulk meter jumped in May/June 2022. There was no evidence of leakage above ground. Installation of new valves and employment of a listening device eventually found leaks which were then fixed.

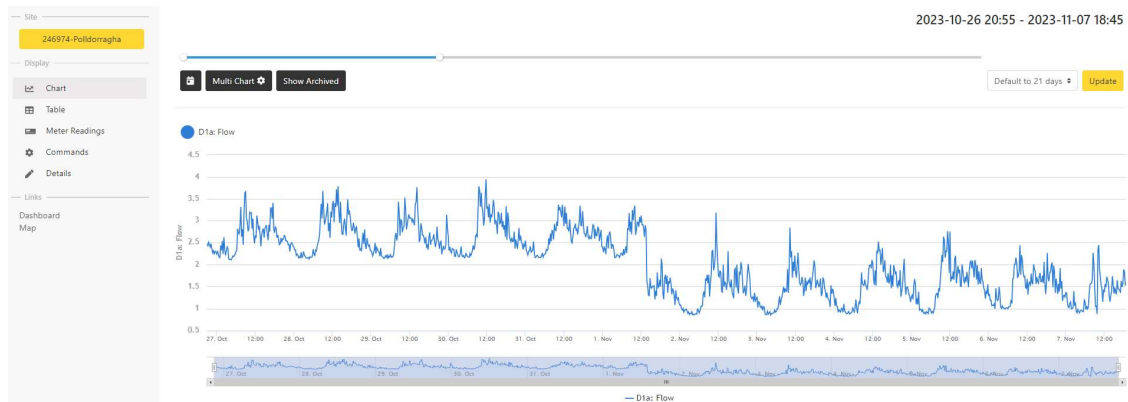
Polldorragha bulk meter

2. Polldorragha DMA was showing high usage in October 2023. A text appeal resulted in a call from a farmer reporting an area of soft ground. A mains leak was found nearby and was fixed, bringing usage back to normal.

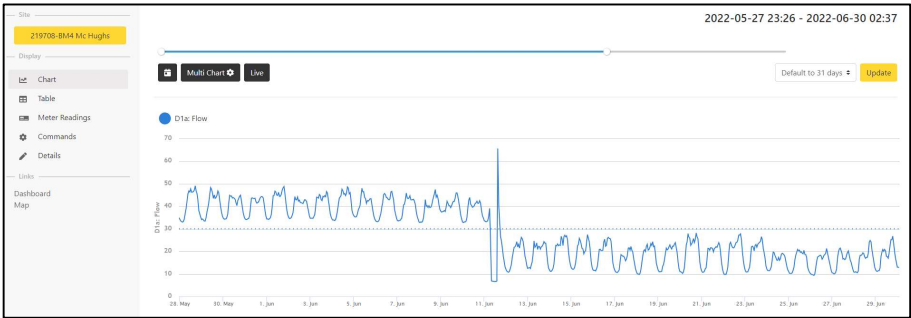
1,2,3

Charts from McHughs bulk meter showing leak fixes along the spine main. The leak numbers correspond to those in Figure 9 and Table 3.
